# Manhole Inspection Summary

Manhole # S51KK\_002MH

**Location** Address: **Ellwood Ave**

Cross Street: **Lanvale St**

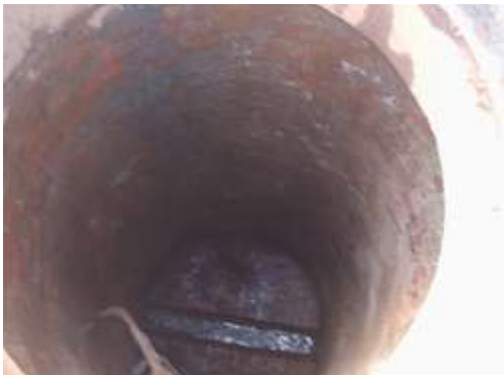
Defect 1

Infiltration: ☐ None ☐ Joint ☐ Cracks ☐ Mortar ☐ Roots ☒ **Wall**

Infiltration

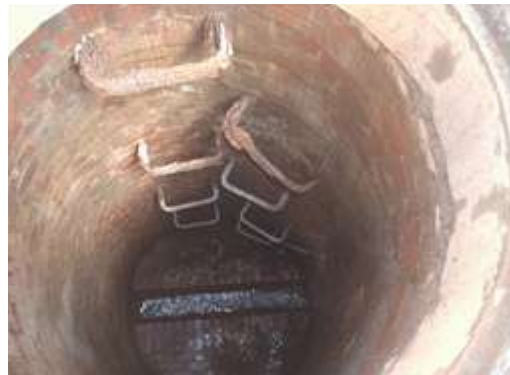
Defect 2

☒ **Leaks**

Frame leaks

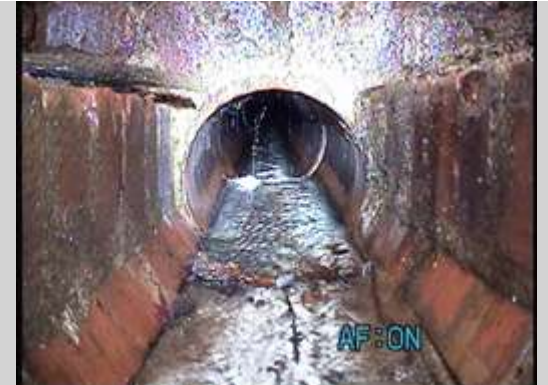
12 O'Clock Outflow

8 in. Circular Gravity Sewer  
Pipe Out @ 12 O'Clock

Pipe Height: **8.4** (in.) Rod and Bar (Angled)  
Pipe Material: **Clay** ☐ Pipe Lined  
Invert Depth: **13.25** (ft.) Flow Characteristics: **Fast**  
Deposits: ☒ None ☐ Mud ☐ Sludge ☐ Debris ☐ Grease  
Silt Depth: (in.) Deposits Extent:  
Infiltration: **None** Pipe Seal Cond: **Sound**

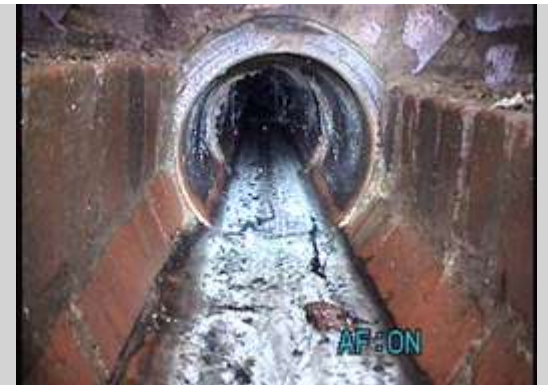
6 O'Clock Inflow

8 in. Circular Gravity Sewer  
Pipe In @ 6 O'Clock

Pipe Height: **8.4** (in.) Rod and Bar (Angled)  
Pipe Material: **Clay** ☐ Pipe Lined  
Invert Depth: **13.10** (ft.) Flow Characteristics: **Fast**  
Deposits: ☒ None ☐ Mud ☐ Sludge ☐ Debris ☐ Grease  
Silt Depth: (in.) Deposits Extent:  
Infiltration: **None** Pipe Seal Cond: **Sound**
